# **On-Site Hog Farm Mortality and Birth-Related Tissue Composting Demonstration Project**

## **General over view of the project**

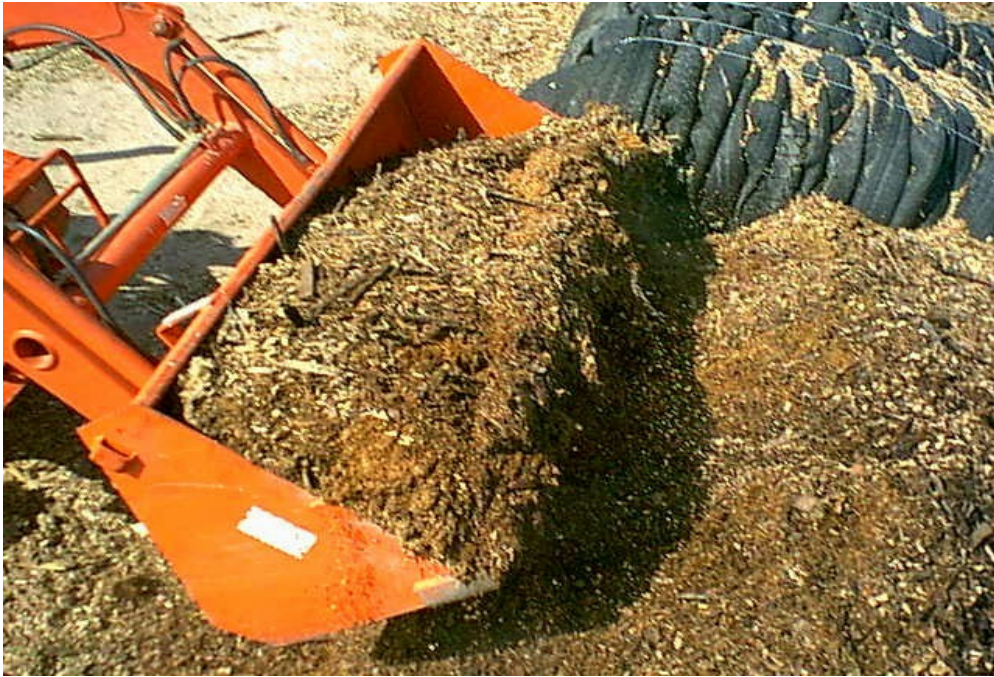
In this project, baled tires were used for the sidewalls of the compost bins. Fourteen bins were constructed on two different large scale hog farms in Yuma County, Colorado. The bins were constructed on concrete pads to reduce the amount of leachate from the bins. Temperatures of both the composting material as well as the outside weather were monitored daily (except weekends and holidays) through the process. Originally, the bins were to be loaded in about ten days then allowed to set for forty-five days, be turned and set for another forty-five days to complete the composting process.

At Site 1 the piles were allowed to sit for 30 days, were turned and allowed to sit for another 30 days then turned and allowed to set for a third 30 days. At Site 2 the bins were filled and allowed to set for 45 days then turned and allowed to set for another 45 days as was originally proposed. Site 1 used a quicker turn process due to the large number of mortalities they had just as the project began.

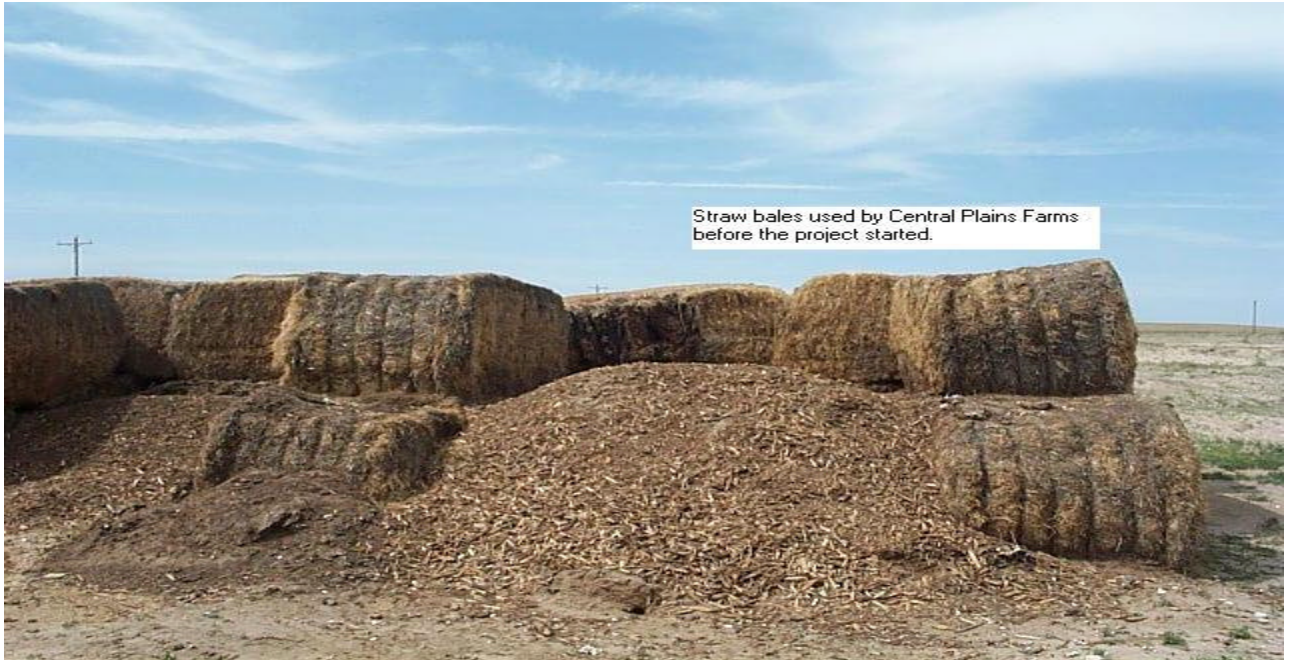
Site 1 used straw bales for a small composting project before this project was started. The straw was not durable enough for long term composting. While used in the composting the bales lasted only about a

year. An advantage to the straw bales is that they provide some carbon to the compost as they deteriorate. Any baled stubble could be used in the composting either as a sidewall or in the compost itself as a carbon source, if they were available.

The straw bales also provided nesting areas for rodents. There is no evidence of rodents nesting in the tire bales during the demonstration project. The tire bales could last indefinitely. The weakest component of the bale is the baling wires. Bob Knecht, a professor with the Chemical Engineering and Petroleum Refining Department of Colorado School of Mines believes the baling wires could be cut on the lower bales without changing the structural soundness. It was believed that by cutting the wires the solar heat would encourage the bales to expand slightly and form a tighter seal to the outside. The Colorado School of Mines conducted their own activity of testing the structural soundness of the bales during this composting demonstration project. They collected data on 2 parameters – deflection and bale temperature. Preliminary data demonstrates that there is very little deflection. The tires move less than  $\frac{1}{4}$  inch. The bale temperature tracked very closely with the outside temperature. The tires were consistently 30 degrees lower than the outside air temperature.

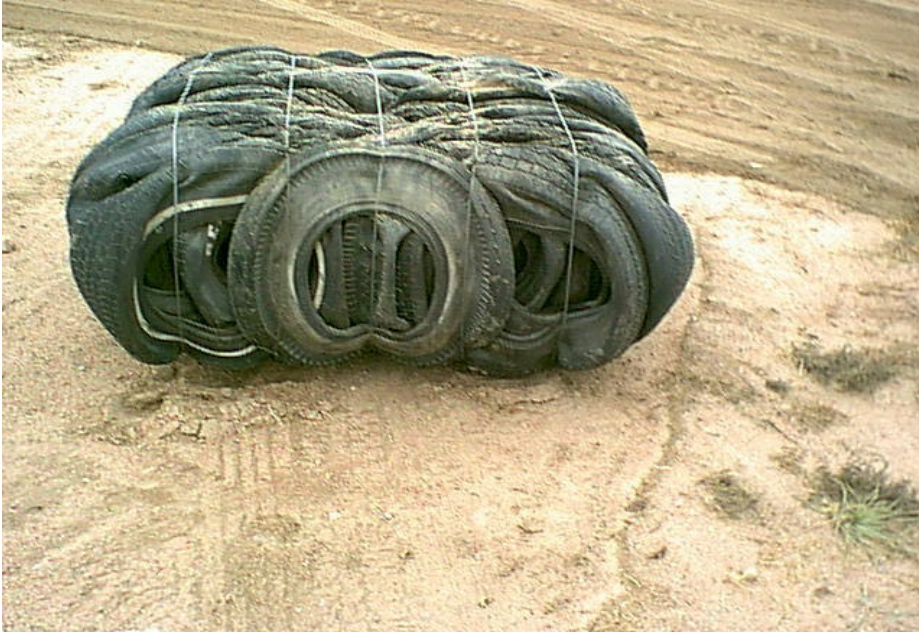
The sidewalls were made with tire bales obtained from Midway Tire Disposal/Recycling Inc. The bales are approximately 56" by 50" by 30" and contain about 100 tires each. The back wall was constructed in a brick-laid fashion staggering the second row over the bottom row. The sidewalls were stacked on top of each other. The interior of each bin was approximately 12' wide and 5 feet tall. The bales were placed so as to reduce contact of the baling wires with the compost as much as possible. Tire bales were chosen as they were readily available, durable and had not been used in this fashion previously. Site 1 had used straw bales in the past and were anxious to try a more suitable sidewall.

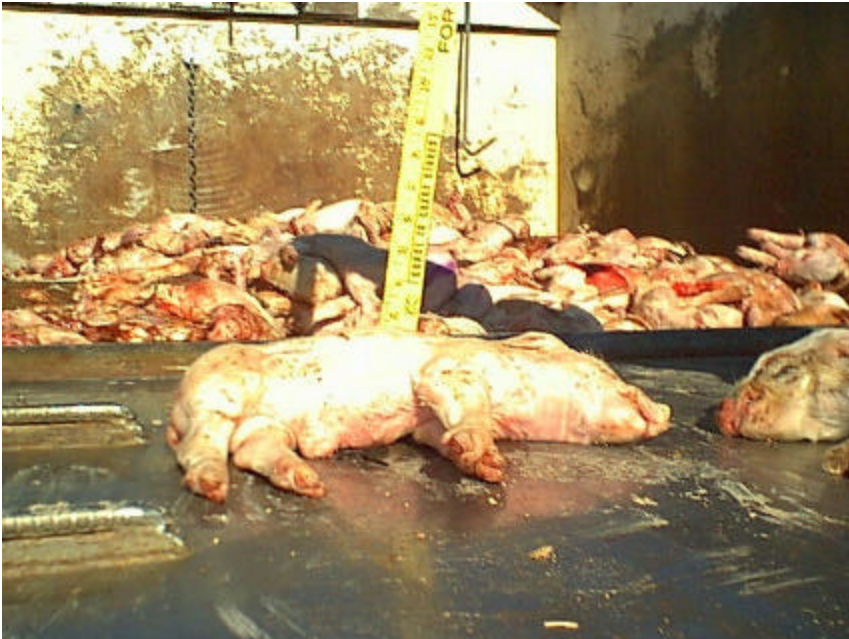
Site 1 began by using frozen “bucket” pigs. These are animals that are small enough to fit in a five-gallon bucket

The pigs were frozen because the process was to remove them from the barns late in the day and leave them outside for pickup in the morning. The overnight temperatures were in the teens to below zero for most of November and December. The frozen pigs prevented any decomposition to occur. Once this problem was identified the buckets were stored in the hall inside of the barns. This kept the pigs from freezing. Frozen carbon sources could also cause this problem & should be avoided.

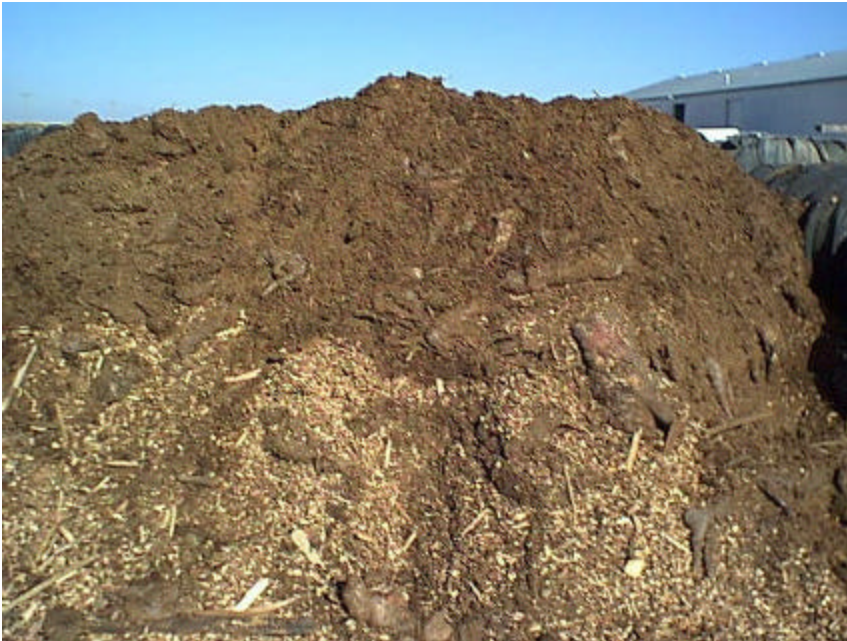
The cap needs to slant toward the outside of the bins, thereby shedding precipitation to the outside of the bins. A cap also helps keep out coyotes. There was a significant problem with coyotes and possibly other vectors at Site 1. The cap and buffer material between the bin sides and front needs to be thick enough, at least 15 to 24 inches to deter wildlife from using the composting pile as a nourishment source.
